February 5, 1985

Mr. Richard Ramirez
Astroline Communications Co.
WHCT-TV
City Place, 31st Floor
Hartford, Conn. 06103

As requested by Mr. Charles Perry of Moffett, Larson and Johnson P.C., we have received your tower site location on Avon Mountain, in Avon, Conn., to determine the height of the tallest guyed tower which can be built on the plot.

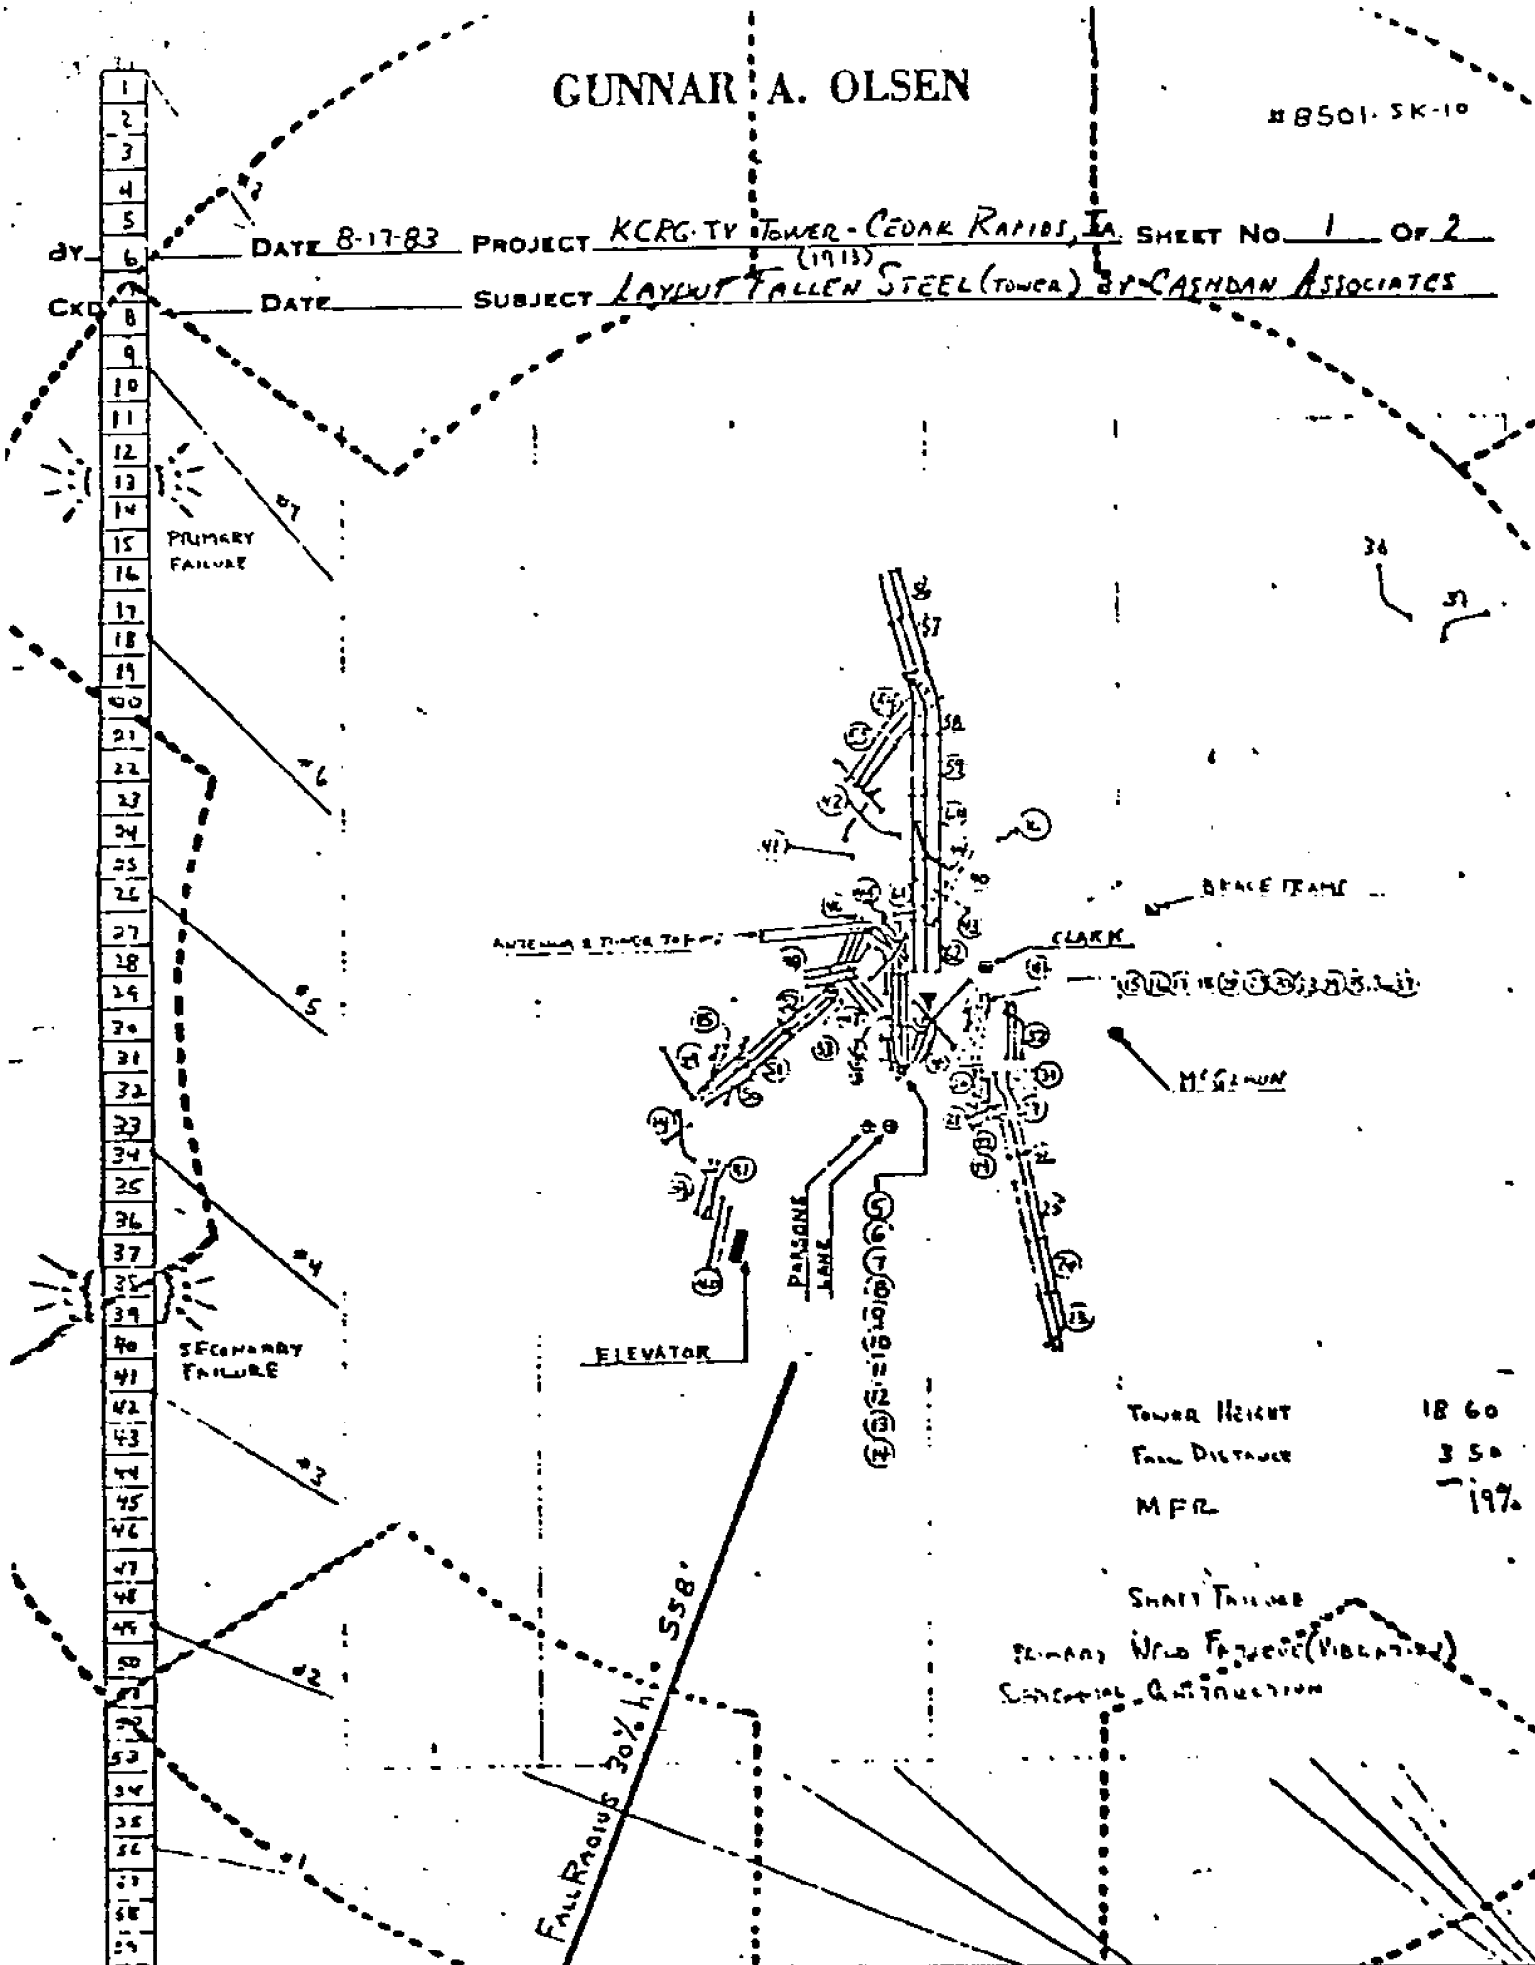
#8501-SK-10

BY _____ DATE 8-17-83 PROJECT KCRG-TV TOWER - CEDAR RAPIDS, IA SHEET NO. 1 OF 2
 CKD _____ DATE _____ SUBJECT LAYOUT FALLEN STEEL (TOWER) BY CASHDAN ASSOCIATES

TOWER HEIGHT	1860
FALL DISTANCE	350
MFR	19%

SHALL FRAME
 SHALL WELD FABRIC (VIBRATED)
 SPECIAL CONSTRUCTION

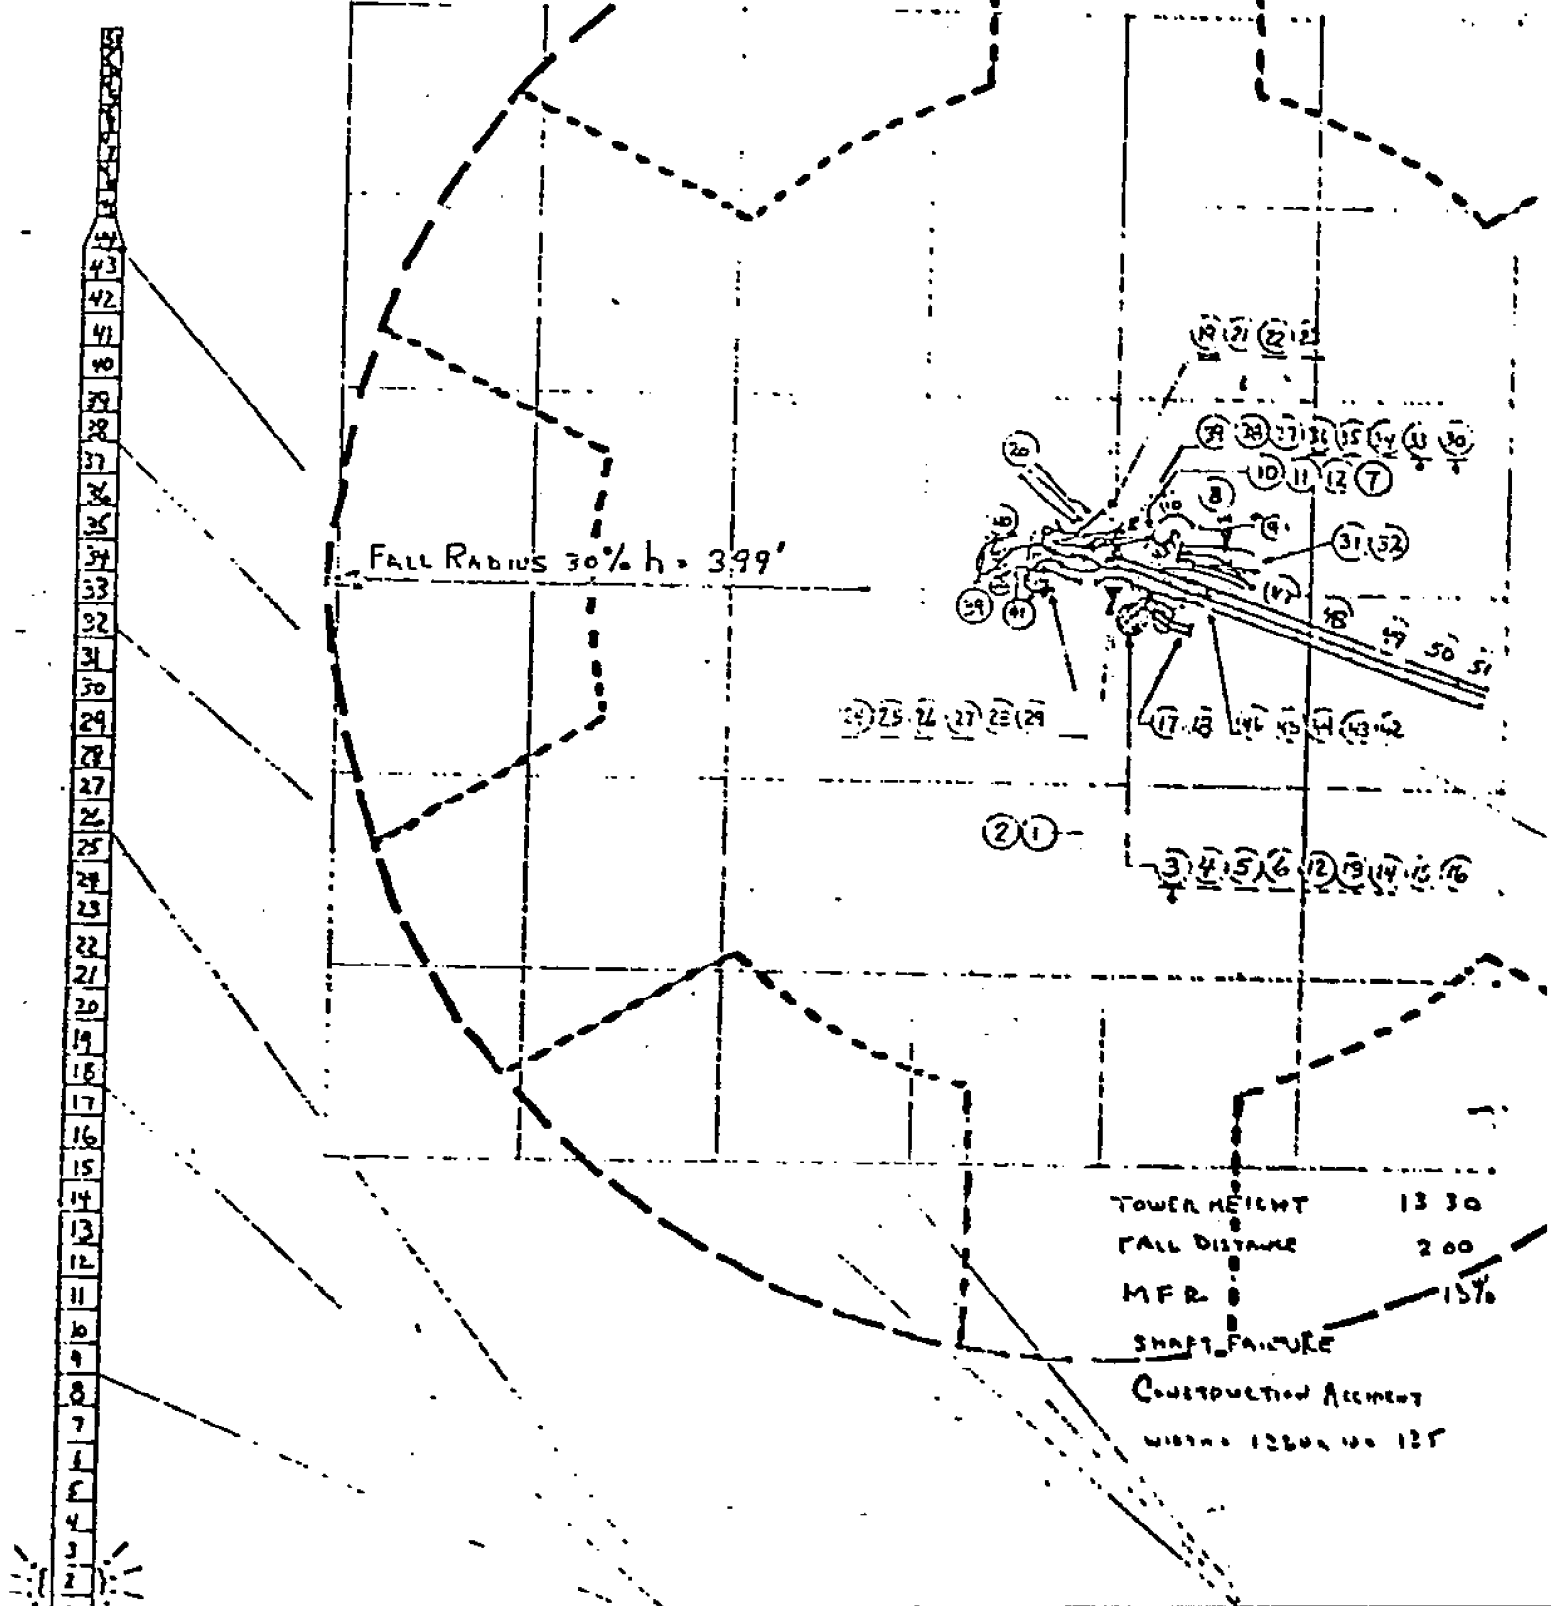
#8501-SK-11

CKD. BY _____ DATE _____ SUBJECT LAYOUT FALL RADIUS STEEL BY GUNNAR A. OLSEN

FALL RADIUS 30% h = 399'

TOWER HEIGHT	1330
FALL DISTANCE	200
M.F.R.	15%
SHAFT FAILURE	
CONSTRUCTION AGREEMENT	
WITH	12504 100 135

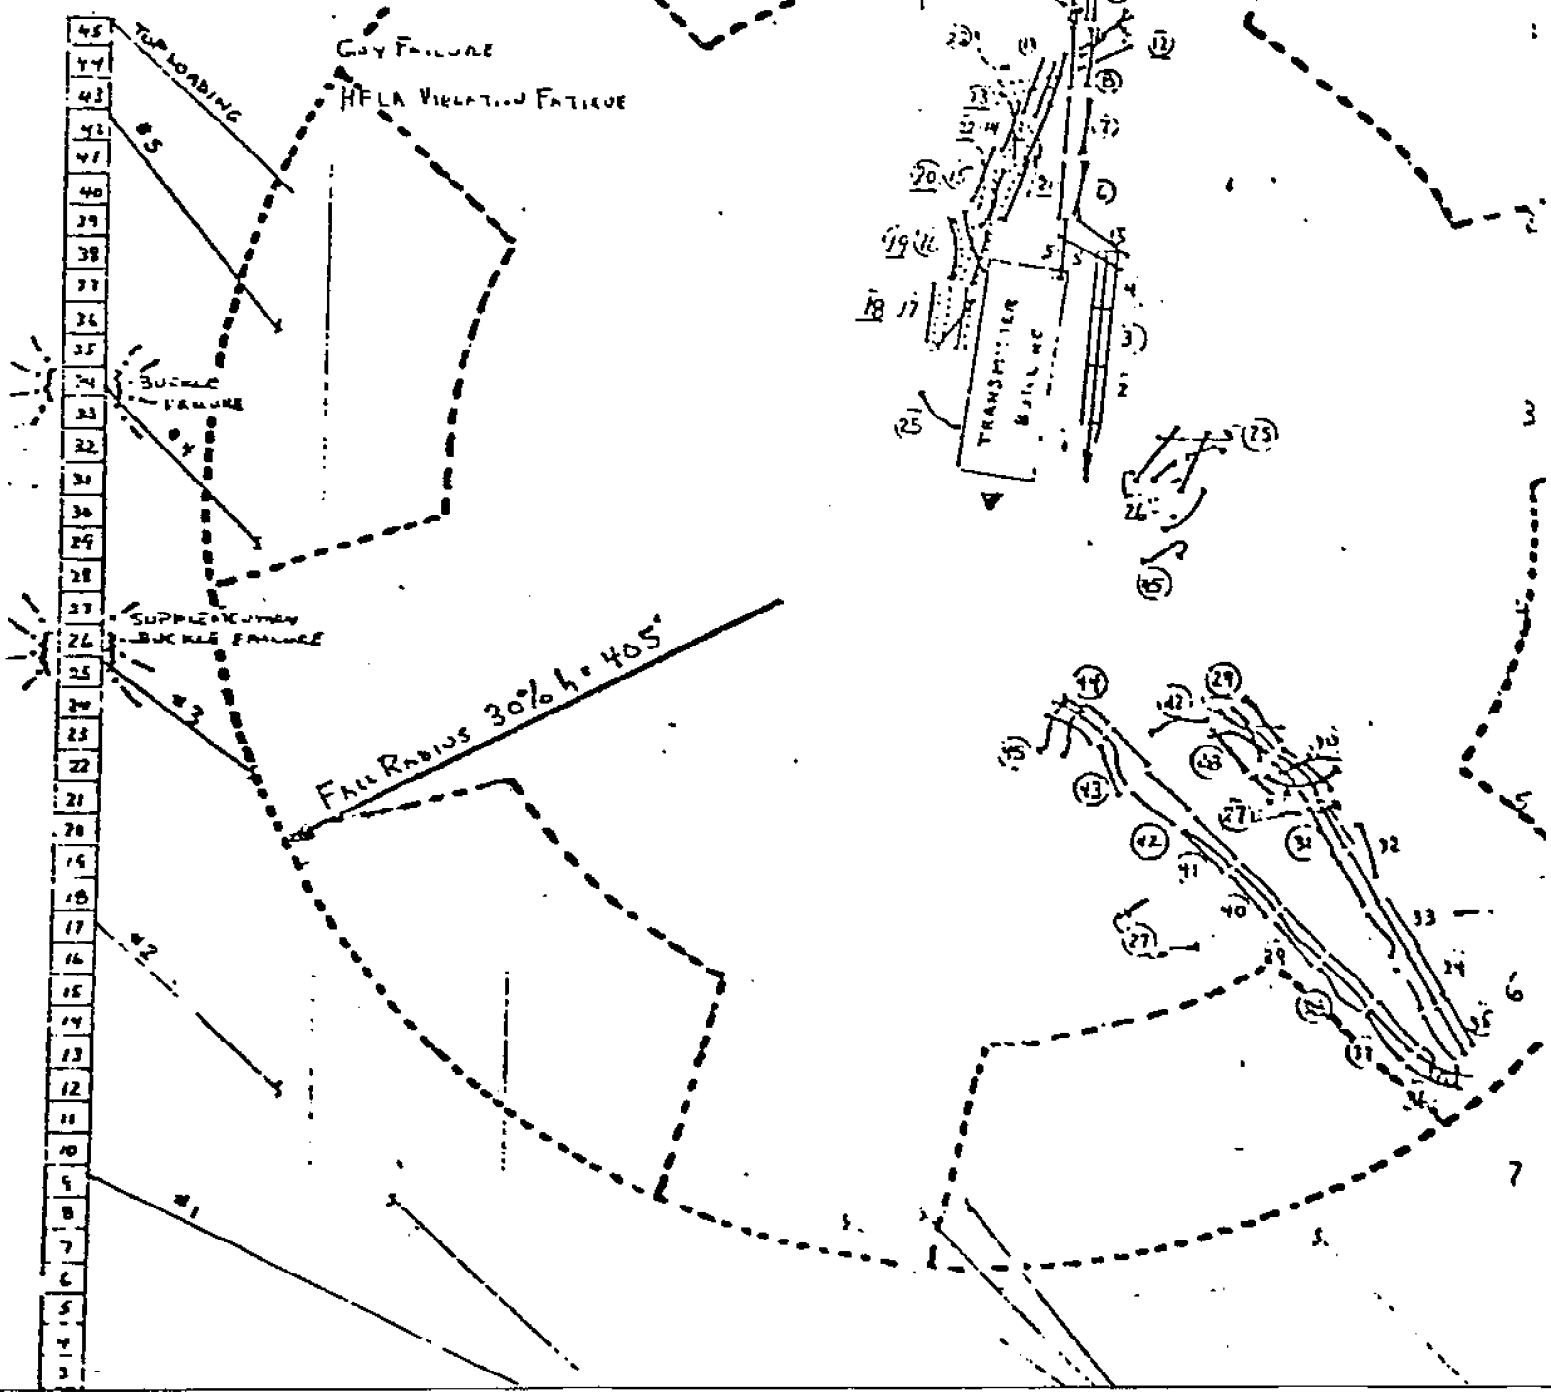
#8501 SK-13

A review of the surveyed plots will show that the only tower which reached 29% was a Loran "C" tower which had heavy insulators in the guys. The proposed tower does not have guy insulators.

DATE B-11-83 PROJECT GREENLAND A.S.C.G. LORAN C TOWER SHEET NO. 1 OF 2
(1964)

6	5	4
Tower Height	1350'	
Fall Dist	370'	
MFR	29%

Gay Failure
HFLA Violation Fatigue

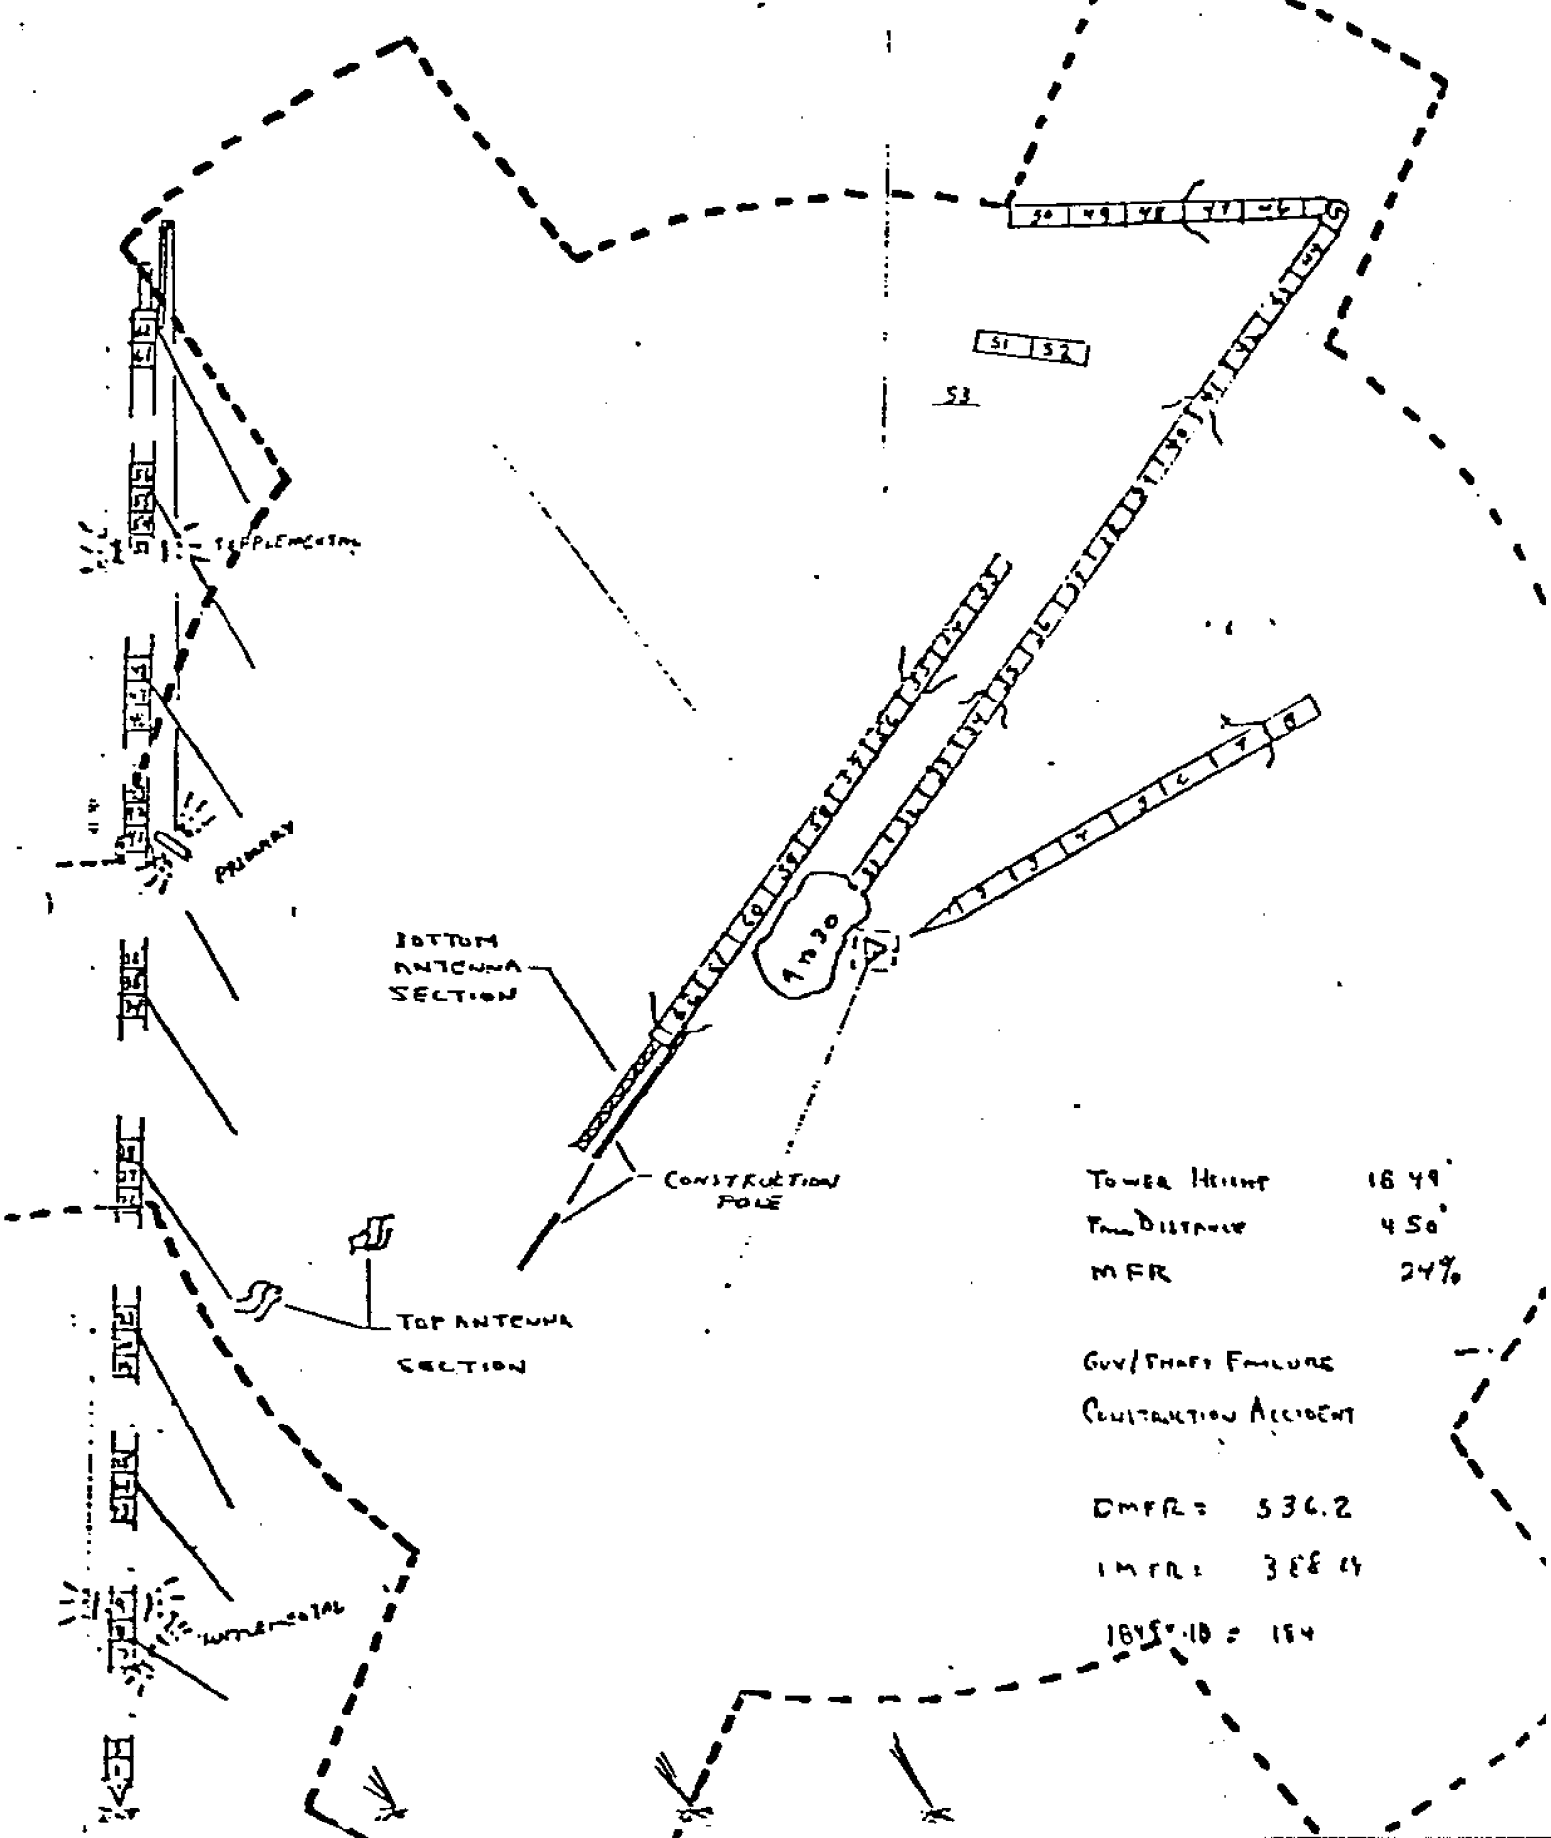
SHEET NO. 1 OF 1
 JOB NO. 8501
 51K-14

SUBJECT S.R. I.G. HOUSTON
 LAYOUT OF FALLEN TOWER STEEL

TOWER HEIGHT 1849'
 TAN DISTANCE 450'
 MFR 24%

GVV/SHAFT FAILURE
 CONSTRUCTION ACCIDENT

D MFR = 536.2
 I MFR = 388.4
 $1849 \times .18 = 333$

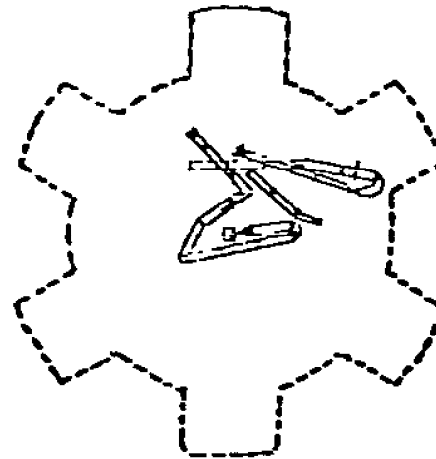
SHEET NO. OF
JOB NO. B501
SK-15

SUBJECT CAPITAL CITY'S CABLE-PUMP, 160'
LAYOUT FALLING TOWER STEEL
400' MICROWAVE (TUBULAR TOWER)

OMFR = $.29 \times 400 = 116'$

IMFR = $.21 \times 400 = 84'$

TOWER HEIGHT = 400

FAIL DISTANCE = 83'

MFR = 21% (20)

SHAFT FAILURE
ICE STORM
DESIGN ERROR

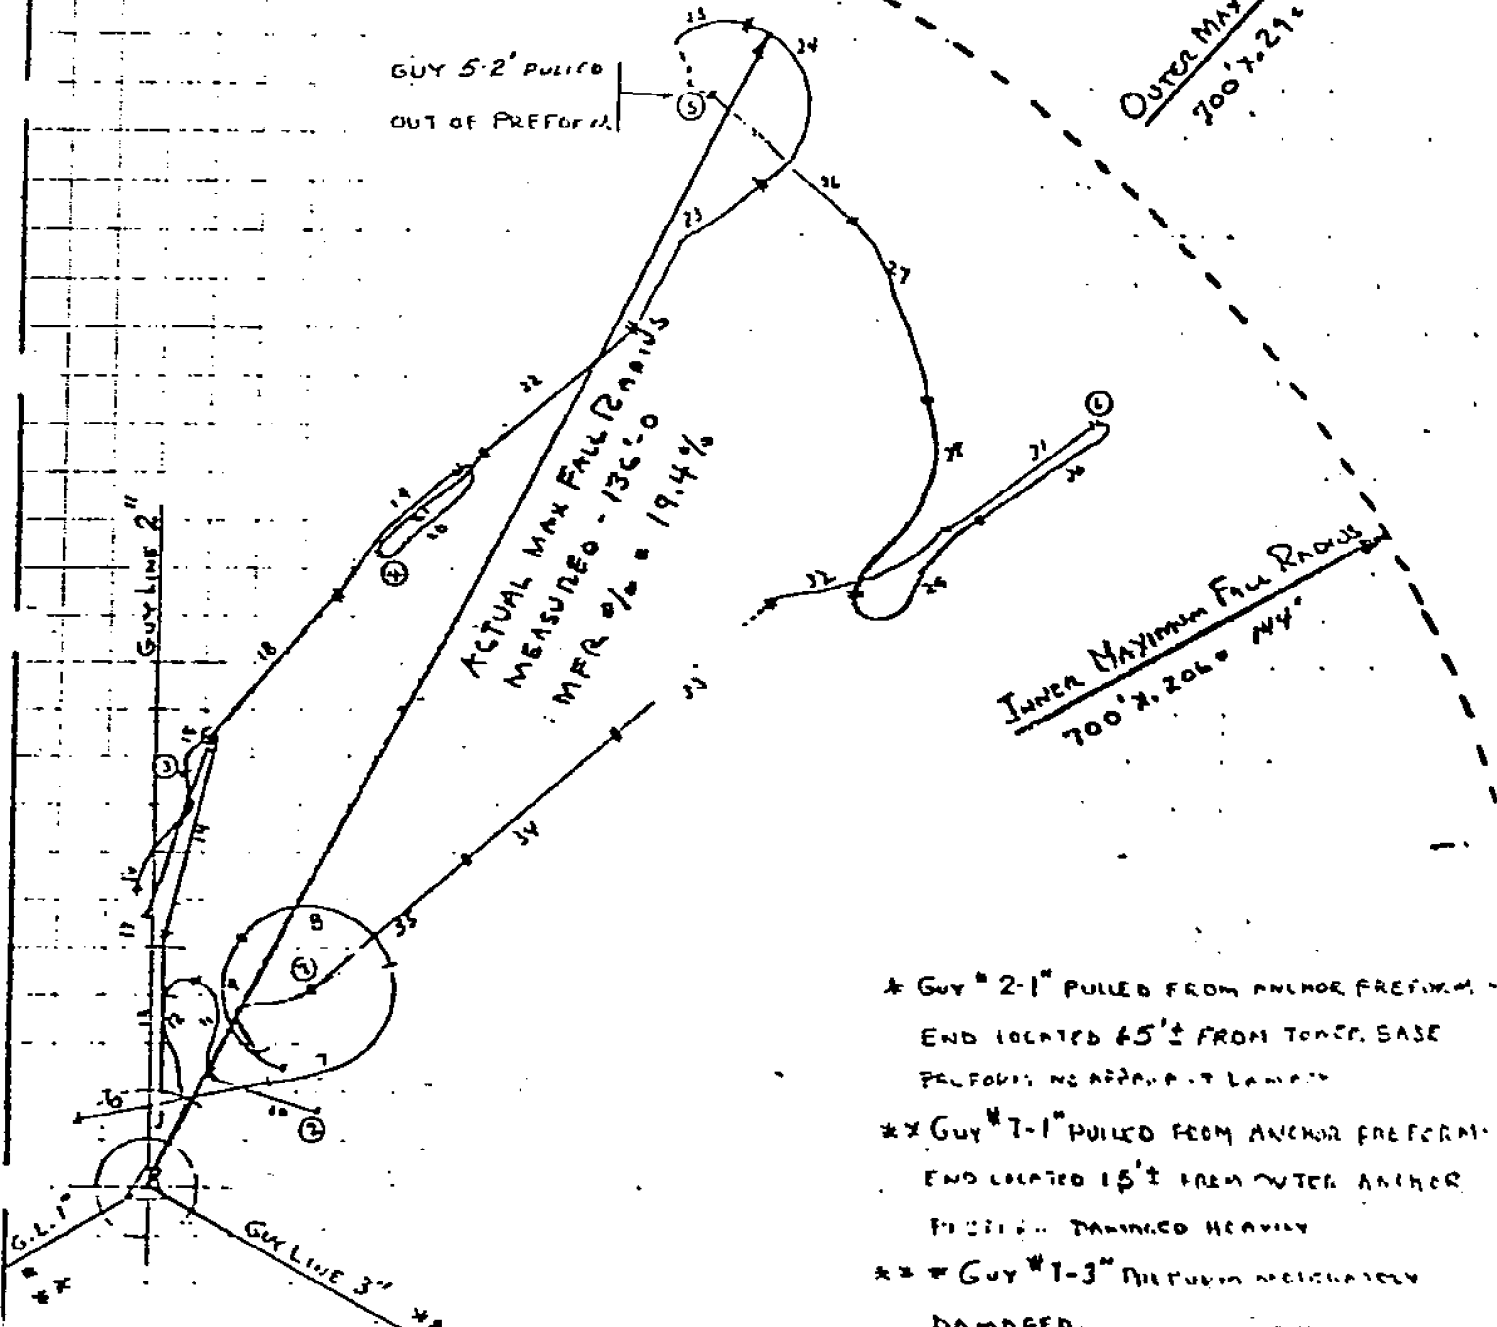
JOB WVTV BANGOR, MAINE
 SHEET NO B501 SK-16 OF _____
 CALCULATED BY G.O. DATE 2-5-85
 CHECKED BY _____ DATE _____
 SCALE 1" = 20'-0"

LAYOUT COLLAPSED TOWER DEBRIS
 BLACK CAP MOUNTAIN-EDDINGTON, MAINE

OMFR = 29% (TH) 203'
 IMFR = 20% (TH) 144.2'

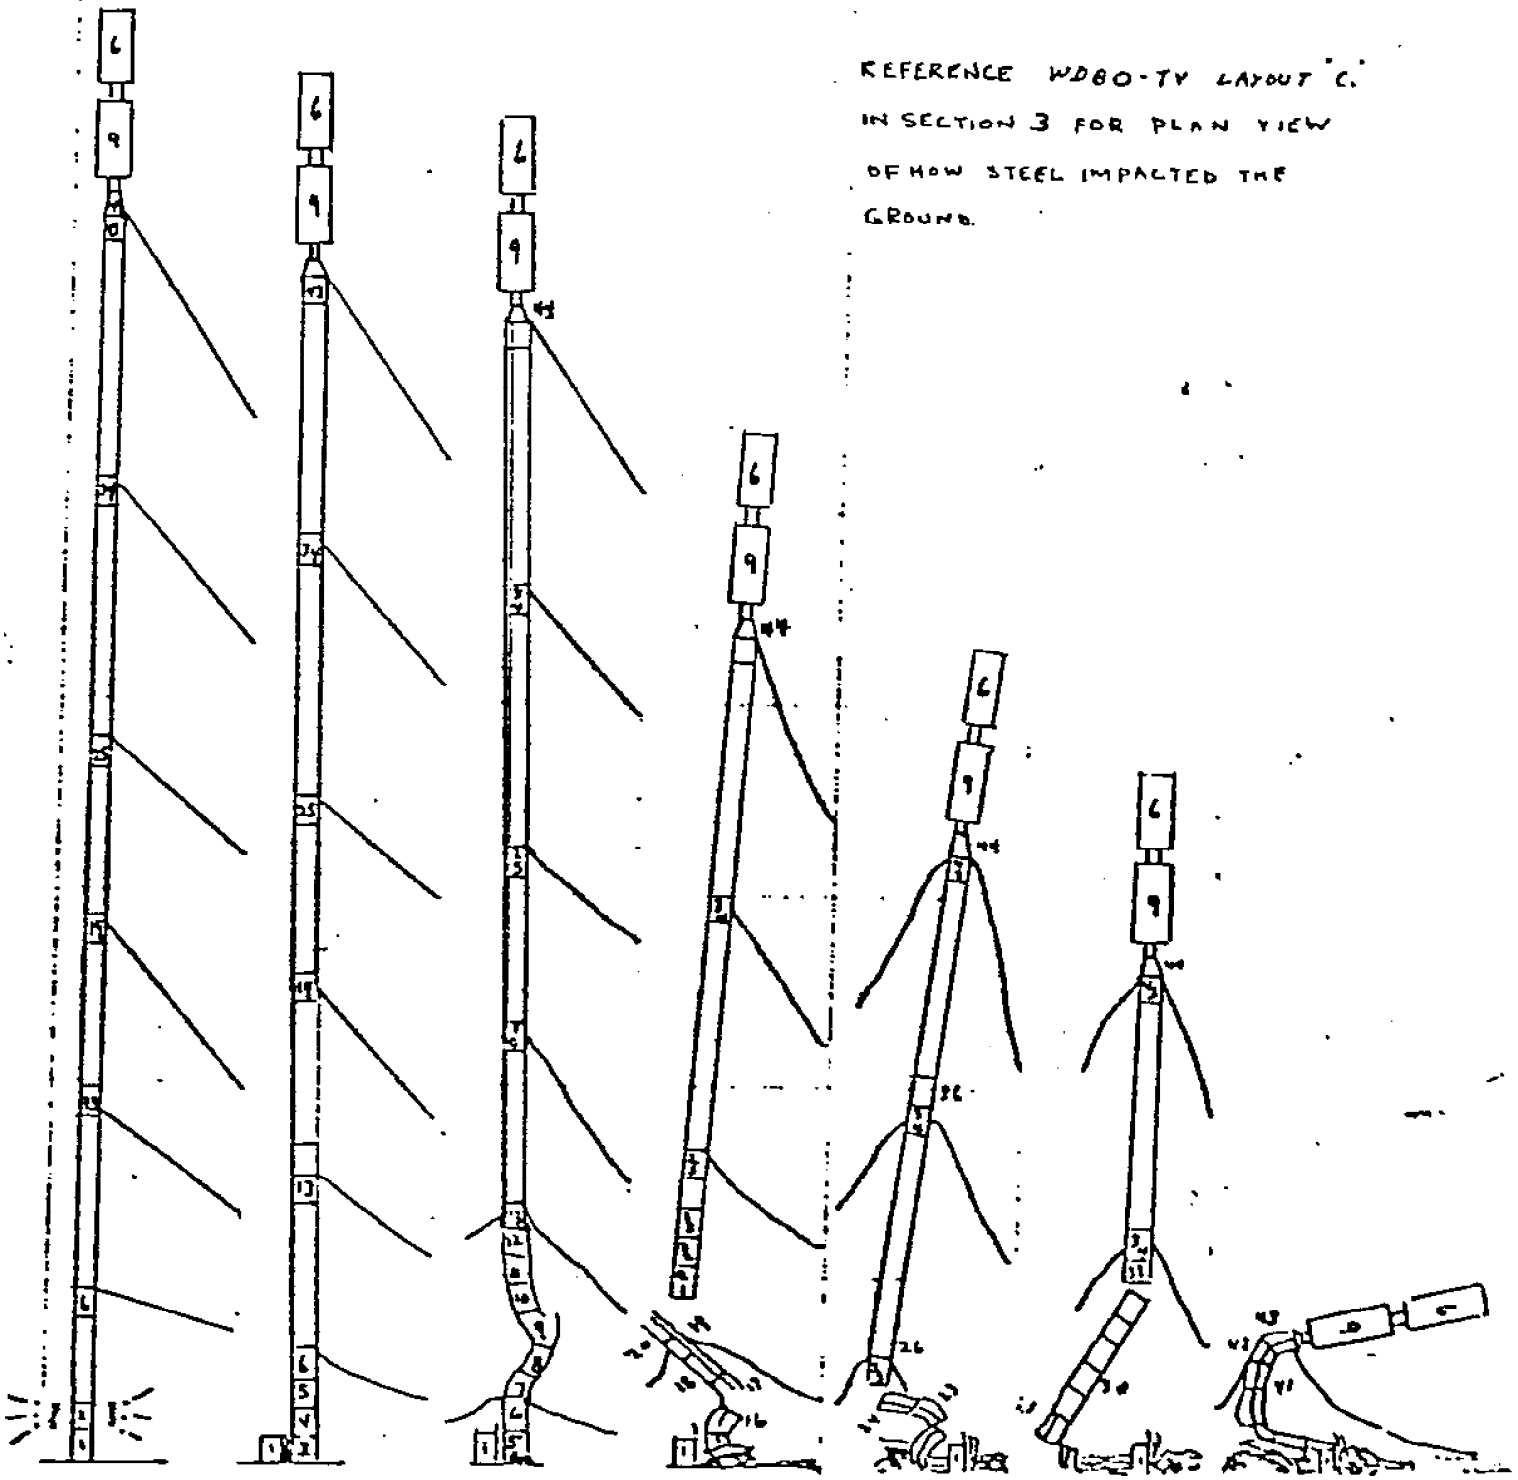
- * GUY # 2-1" PULLED FROM ANCHOR PREFORM - END LOCATED 45'± FROM TOWER BASE. FALFOLDING NO APPARENT DAMAGE
- ** GUY # 7-1" PULLED FROM ANCHOR PREFORM - END LOCATED 15'± FROM OTHER ANCHOR. FOLDING - DAMAGED HEAVILY
- ** GUY # 7-3" PULLED FROM ANCHOR - DAMAGED

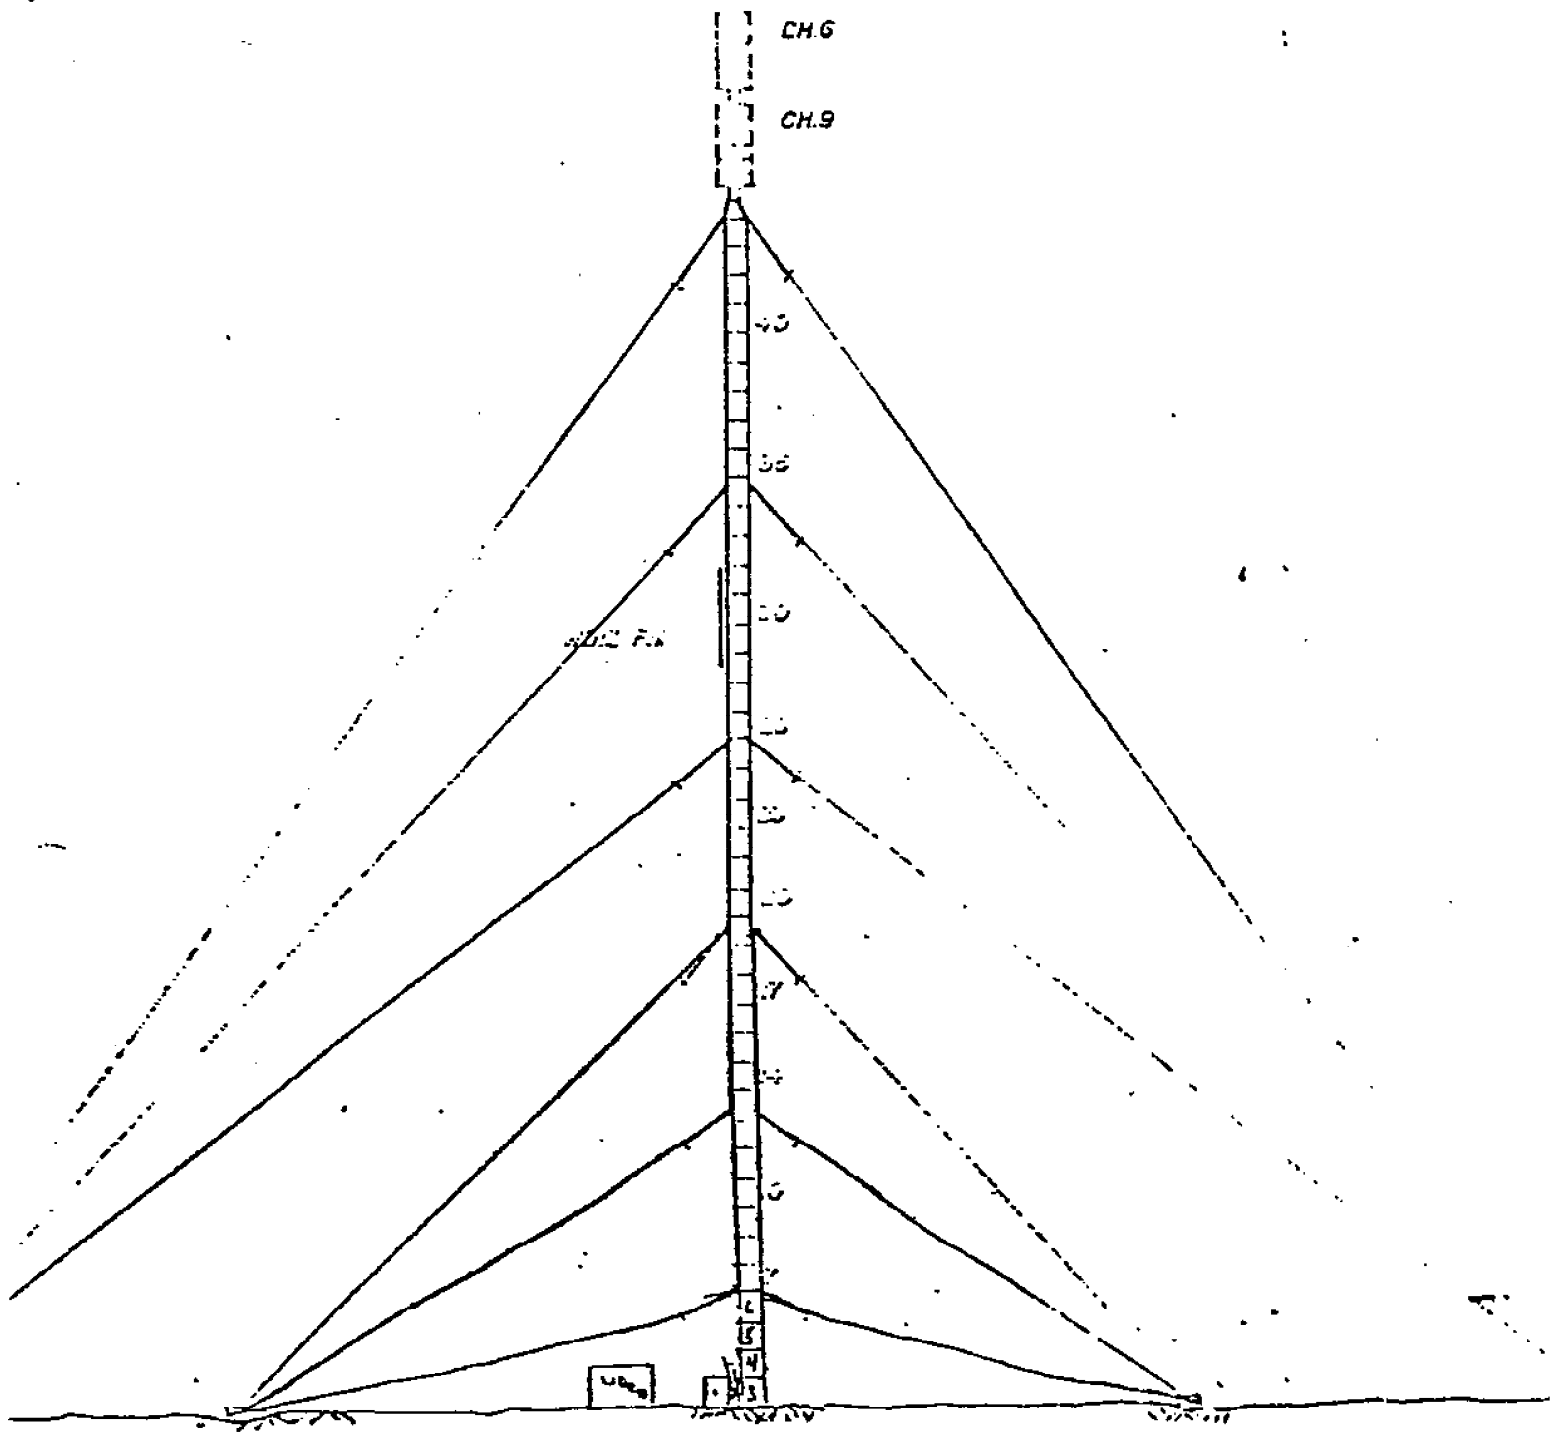
REFERENCE WDBO-TV LAYOUT 'C'
IN SECTION 3 FOR PLAN VIEW
OF HOW STEEL IMPACTED THE
GROUND.
